FRIENDSHIP LAKE LAKE CLASSIFICATION REPORT

**Presented by Reesa Evans, CLM, Lake Specialist
Adams County Land & Water Conservation Department
P.O. Box 287, Friendship, WI 53934**

MARCH 2008

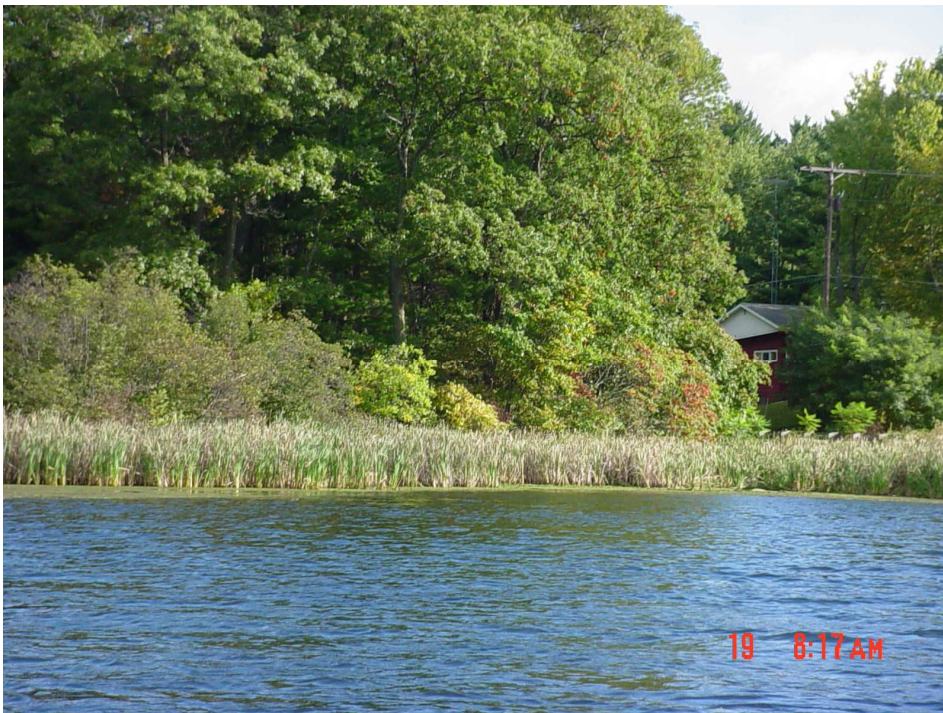
**Figure 8:
Wetland area
on Friendship
Lake’s north
shore**

The large areas of wetlands in the Friendship serve as filters and trappers that help keep Little Roche a Cri and Friendship lake as clean as they are. It is essential to preserve these wetlands for the health of Friendship Lake.

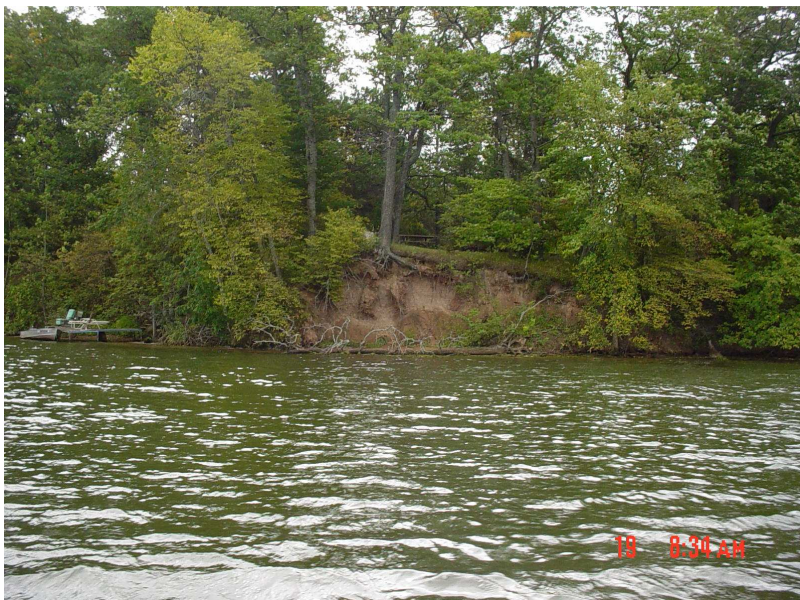
Figure 10: Example of Severe Erosion on Friendship Lake

Friendship Lake has a total shoreline of 5.9 miles (31,152 feet). Much of the lakeshore is in residential use. Many of the areas near the shore are steeply sloped, except at the far northwest end, where the land is flatter and where the beach and boat launch are located. A 2004 shore survey revealed that 75.8% of Friendship Lake's shoreline is vegetated. The rest of the shore is a mix of sand, rock and/or other hard structure. Several areas also have significant erosion occurring, noted in red on the map below. Much of the shore has very steep, sandy banks.

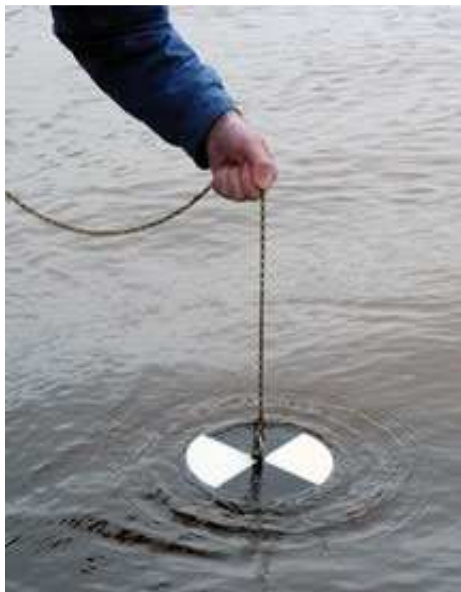
Figure 23: Photo of Testing Water Clarity with Secchi Disk

Water clarity is a critical factor for plants. If plants don't get more than 2% of the surface illumination, they won't survive. Water clarity can be reduced by turbidity (suspended materials such as algae and silt) and dissolved organic chemicals that color or cloud the water. Water clarity is measured with a Secchi disk. Average summer Secchi disk clarity in Friendship Lake in 2004-2006 was 6.52 feet. This is good water clarity, putting Friendship Lake into the "mesotrophic" category for water clarity.

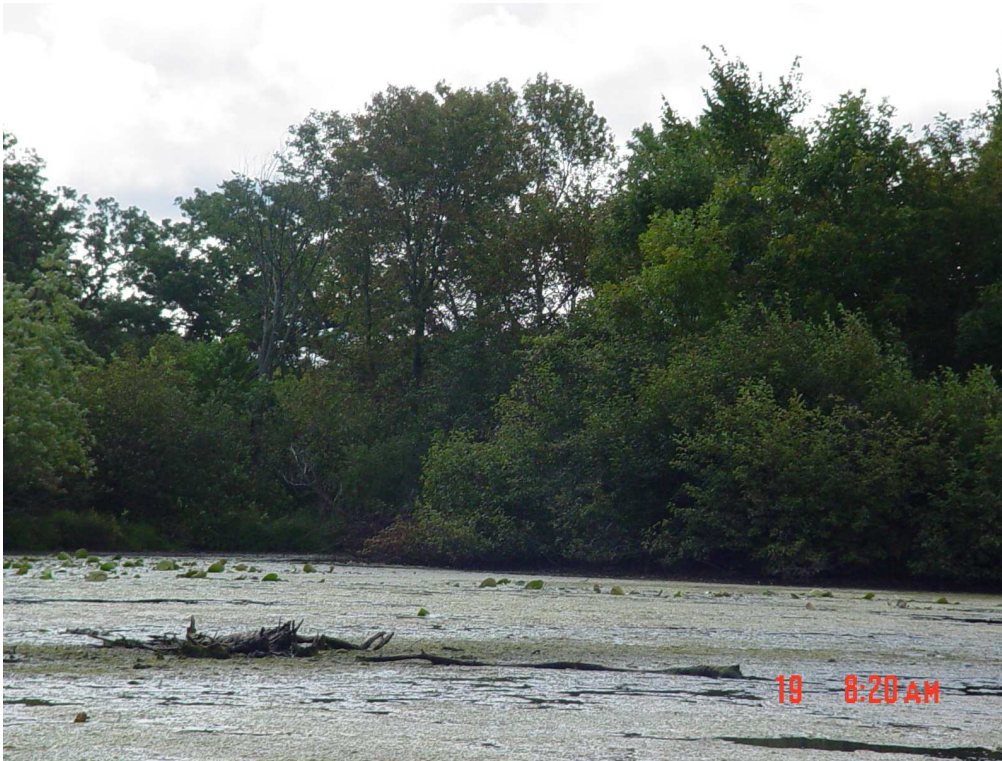
**Figure 48:
Southeast
End of FR1**

This area extends along over 6000 feet of the shoreline on both sides of the eastern end of Friendship Lake. This area of Friendship Lake is very shallow and is largely undeveloped. 46.7% of the shore is wooded; 21.7% has shrubs; the remaining shore (31.6%) is native herbaceous cover. Much of this area is a marsh. Large woody cover is common for habitat. With little human disturbance along this shoreline, the area has natural scenic beauty.

Filamentous algae were found at 100% of the sites in this critical habitat area.

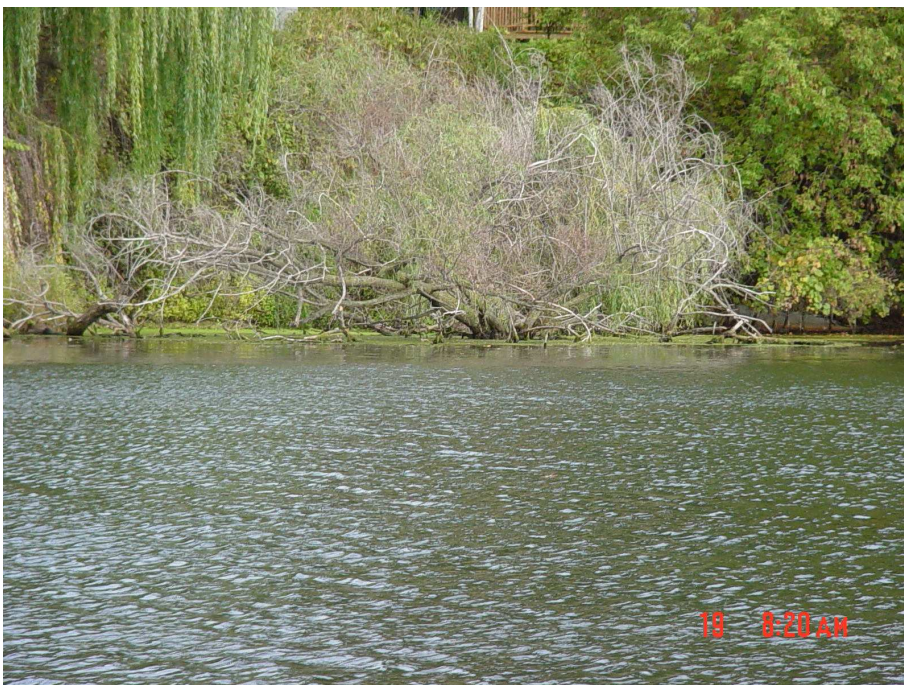
Figure 49:
Southeast Area of
FR2

This area extends along approximately 5000 feet of the north and south shoreline in the middle of the lake's length. 35% of the shore is wooded; 14% has shrubs; 38% is native herbaceous cover. The remaining shoreline is bare/eroded sand and some hard structures. Large woody cover is common for habitat. With minimal human disturbance along this shoreline, some of the area is has natural scenic beauty.

This area of commonly-occurring large woody cover, emergent aquatic vegetation, submergent and floating vegetation provides spawning and nursery areas for many types of fish: northern pike; largemouth bass; bluegill; pumpkinseed; yellow perch; crappie; bullhead; and other panfish. All of these fish also feed and take cover in these areas. Rusty crayfish are known to occur in Friendship Lake, although none were seen during the field survey. Some shore development was present in FR2. Various types of wildlife were seen and heard during the field survey. Upland wildlife are known to use this area as well. Downed logs serving as habitat were also seen

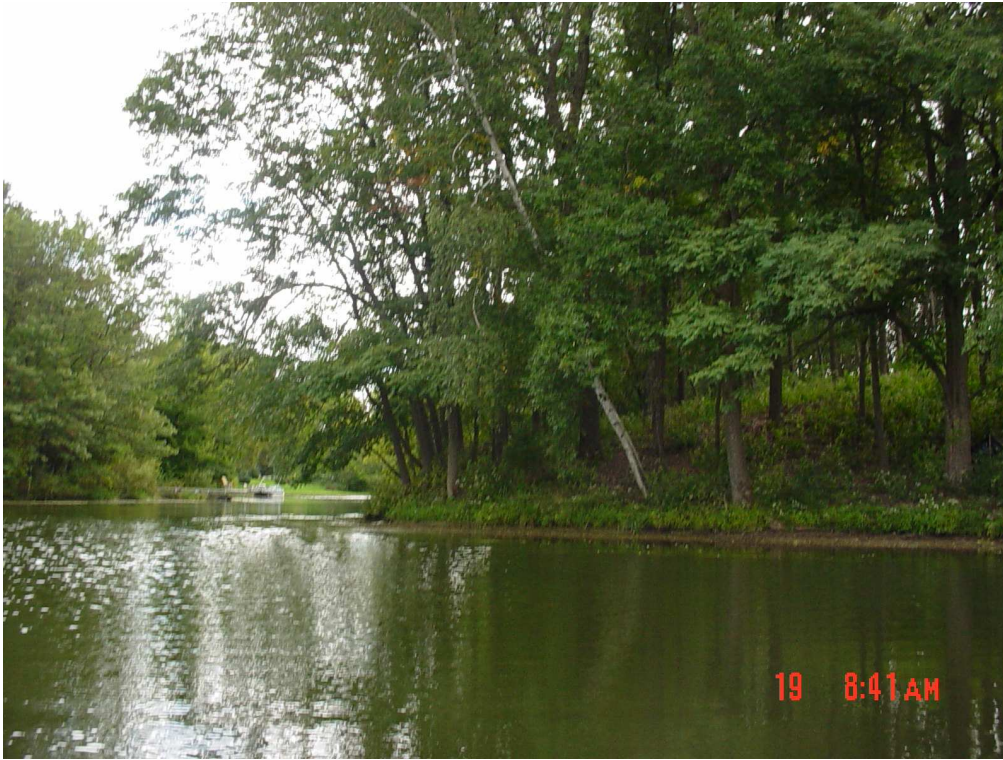
**Figure 50:
Southern Curve
in Area FR3**

This area extends along approximately 2100 feet of the southwest shoreline. 47.5% of the shore is wooded; 5% has shrubs; 15% is native herbaceous cover—the remaining shore is bare sand and hard structure. This critical habitat area includes some of most developed area of Friendship Lake, although the southeast side of this area is currently undeveloped. Large woody cover is present, but not as much as in the other two critical habitat areas. Scenic beauty in part of the area is lessened on the north and southwest sides due to the human development, but the southeast area of this site is still pretty. This area does still provide spawning and nursery areas for many types of fish, as well as several types of wildlife.

Maximum rooting depth in FR3 was 13 feet. No threatened or endangered species were found in this area. All of the area had filamentous algae, especially near the shores. Only one emergent species was found here. Two species of floating-leaf rooted plants were present. Also present were three species of free-floating plants. Six submergent plant species were found. This is a less diverse submergent community than the other critical habitat sites in Friendship Lake.
